**ROAD EVALUATION AND IMPROVEMENT PLAN
LEATHERWOOD MOUNTAINS SUBDIVISION**

LEATHERWOOD PROPERTY OWNERS ASSOCIATION

September 4, 2008

JWA File No.: 071103

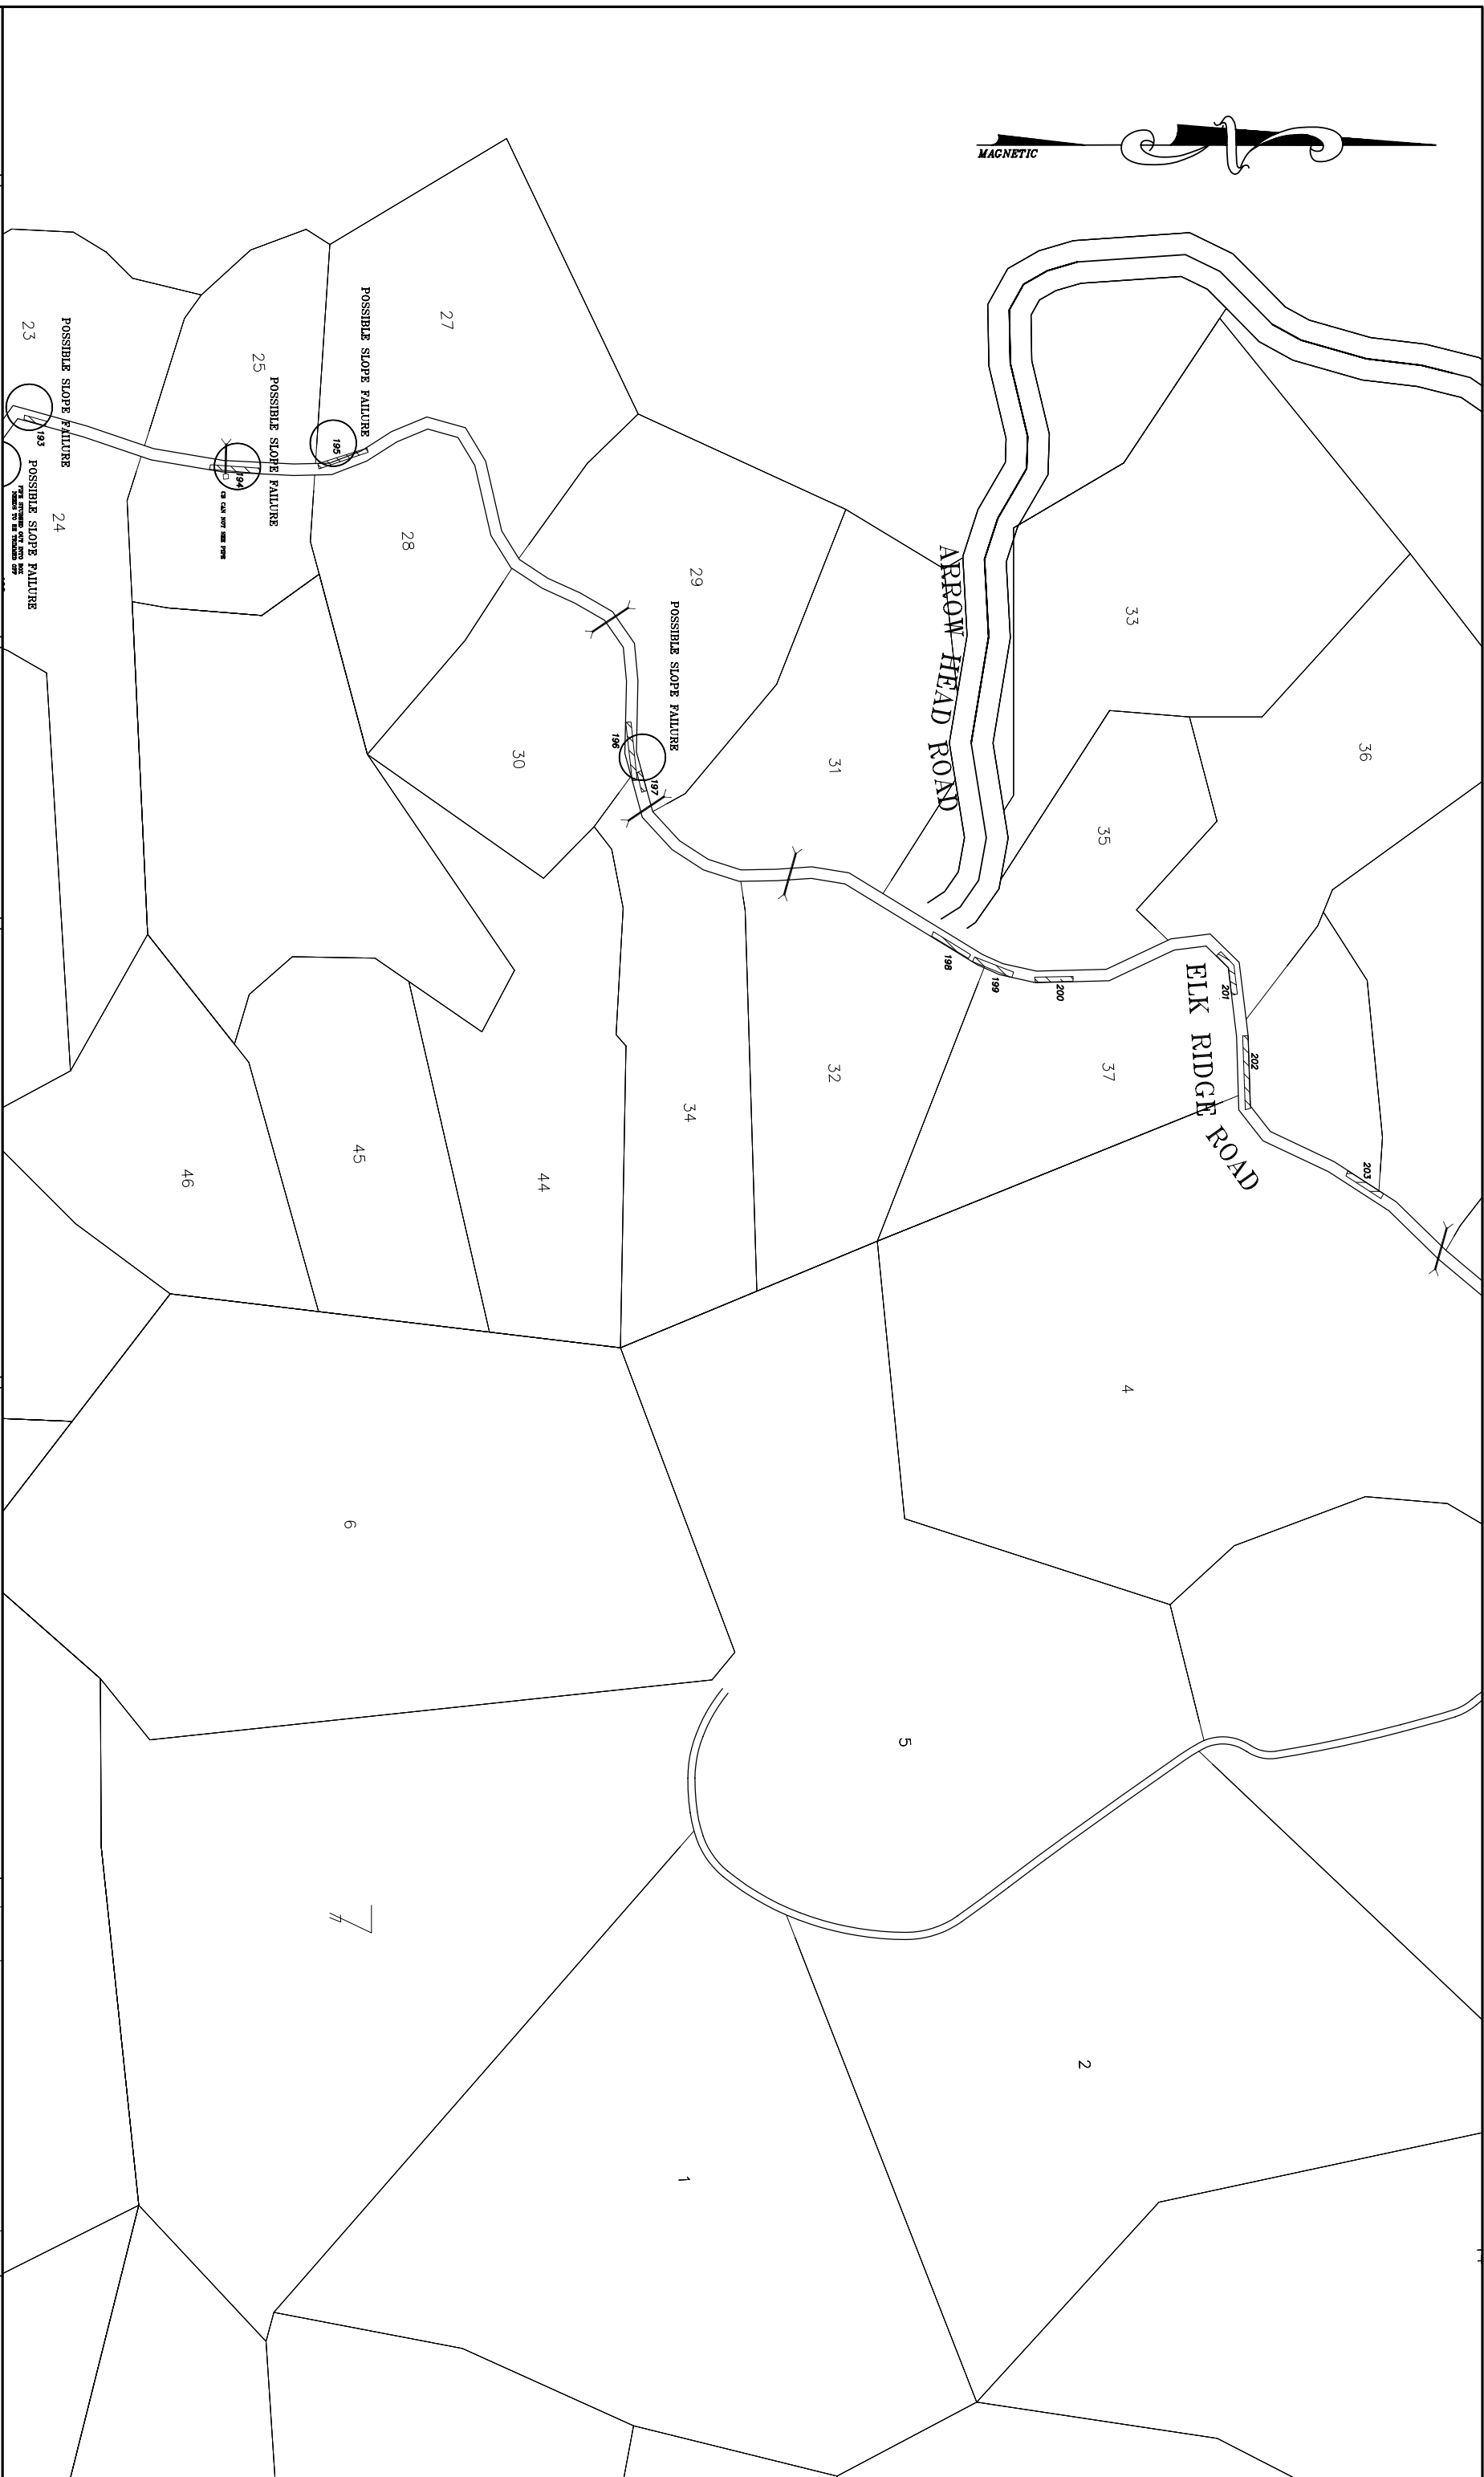
23 POSSIBLE SLOPE FAILURE
193 POSSIBLE SLOPE FAILURE
24 POSSIBLE SLOPE FAILURE
